**NATIONAL AERONAUTICS AND SPACE ADMINISTRATION**

CONTRACT NAS 3-15568

1. Report No. NASA CR - 134502		2. Government Accession No.		3. Recipient's Catalog No.	
4. Title and Subtitle IMPACT RESISTANCE OF FIBER COMPOSITE BLADES USED IN AIRCRAFT TURBINE ENGINES				5. Report Date May 1973

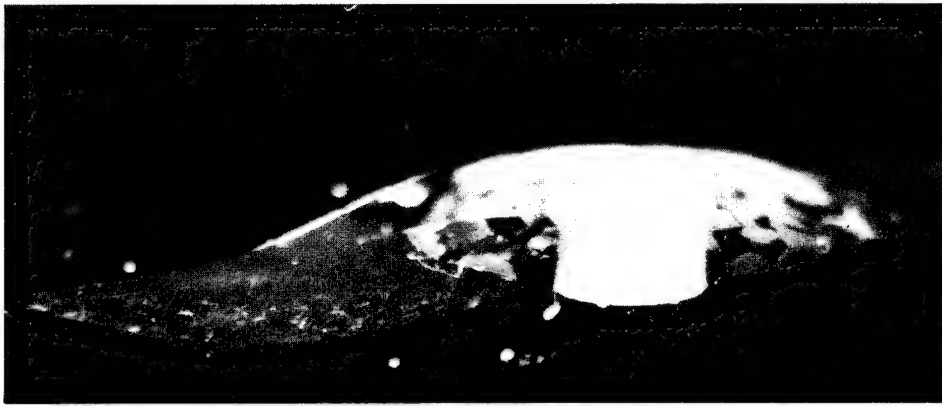
Figure 8 High Speed Strobe Photographs Showing Approach and Impact of a 2.54 cm Diameter Gelatin Ball

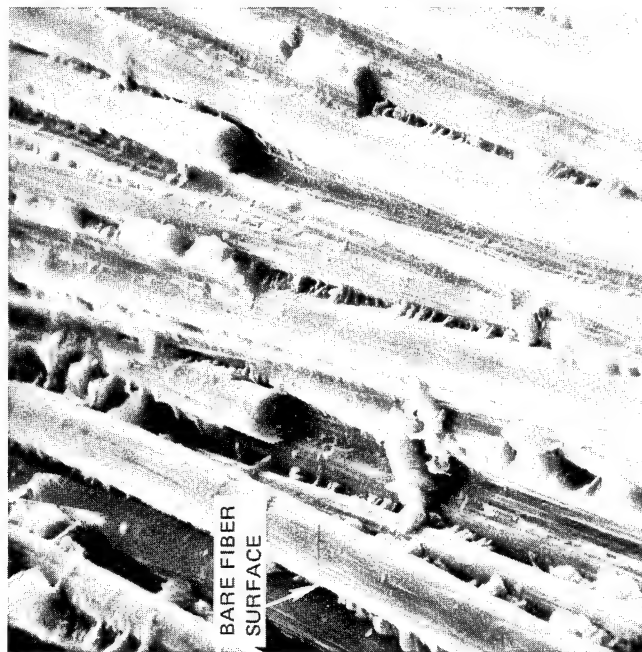
Figure 20 Scanning Electron Microscope Photographs of Typical Interlaminar Fracture Surfaces From Impacted Modmor II/PR-286 Specimens

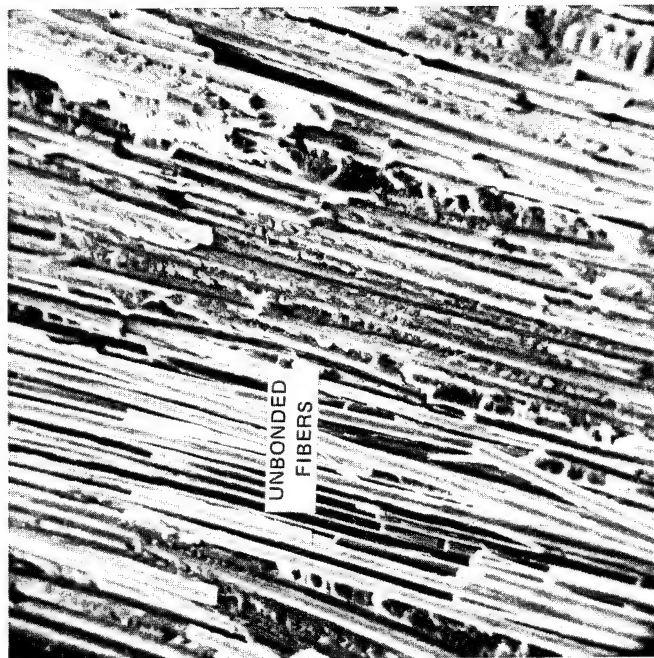
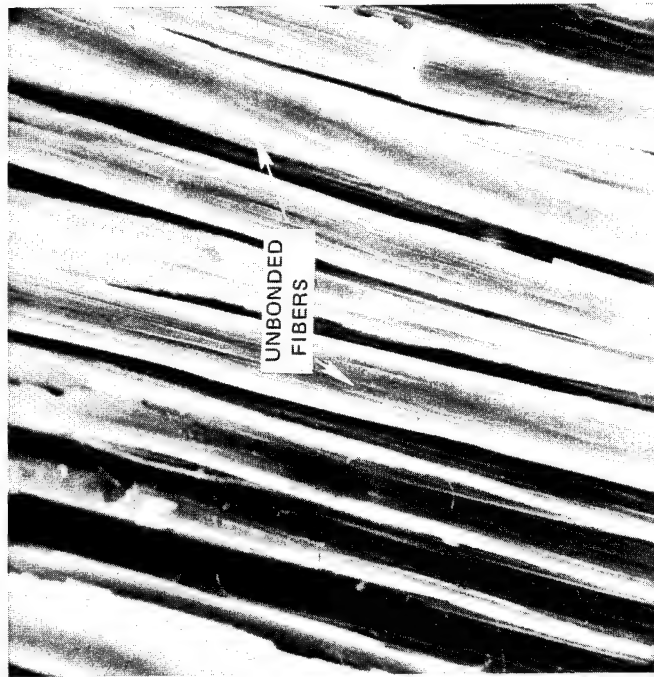
Figure 21 Scanning Electron Microscope Photographs of a Modmor II/PR-286 Transverse Tensile Specimen Fracture. (Note Completely Unbonded Fibers)

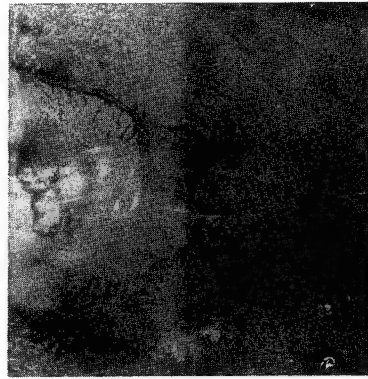
NAS-41

Figure 23 Effect of Ply Configuration Upon Impact Damage to Modmor II/PR-286 Simulated Blade Specimens After Impact at  $15^\circ$  on the Leading Edge With 1.27 cm Diameter Gelatin at 274 m/sec. (Mag: 0.7X)

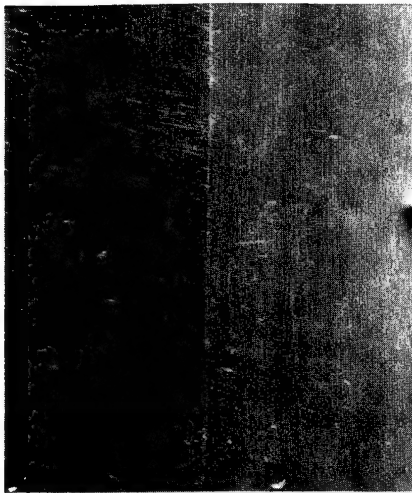
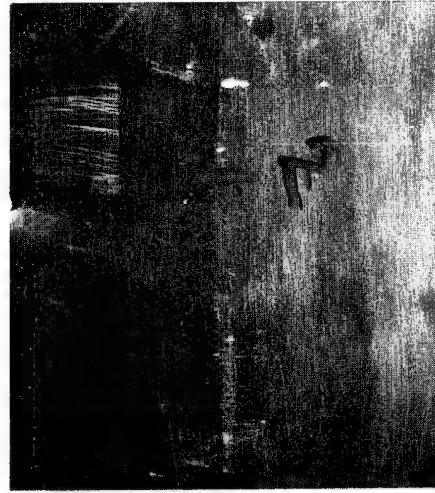
NAS-103

Figure 37 Impact Damage to Titanium -6Al-4V Due to 0.64 cm Diameter Steel Impacts at 15° on the Leading Edge During Spin Test

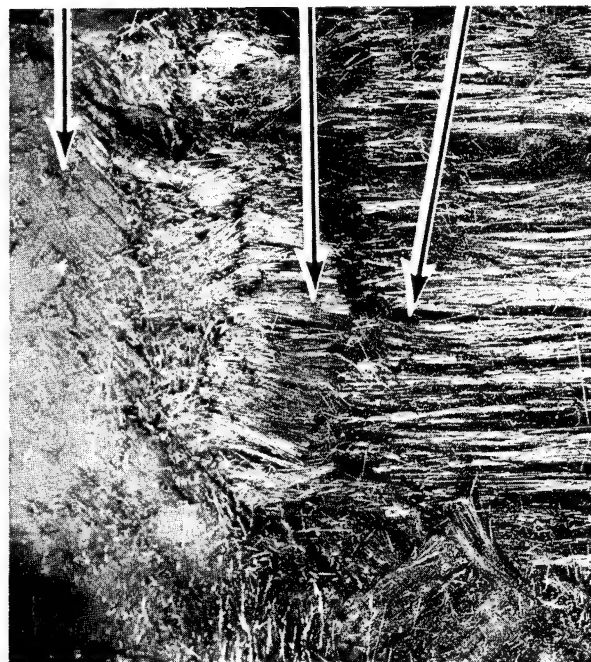
Figure 39 Specimen NAS-29 After Two Glancing Impacts at Mid-Chord With 0.64 cm Diameter Steel at 274 m/sec. Insert 1 Shows Minimal Visual Damage at Impact Points. Inserts 2 and 3 Reveal That Broken Longitudinal Fibers and Delamination Extends Through Entire Specimen Thickness.

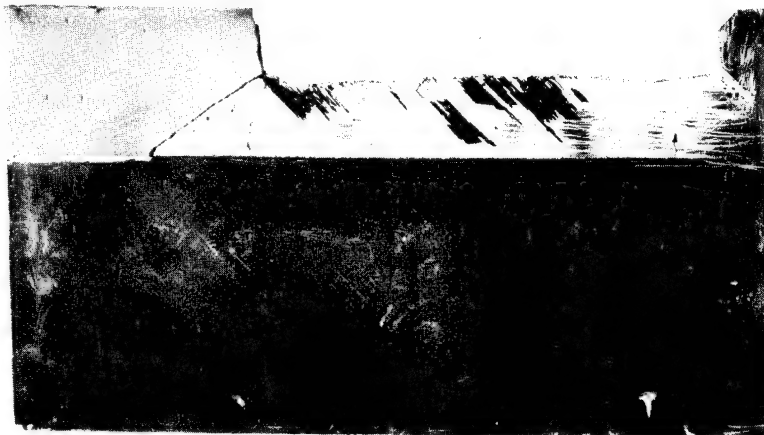
MODMOR II/PR-286  
UNPROTECTED

MODMOR II/PR-286  
WITH FOD SHIELD
